Reference: Sailplane model
H 301 and H 301 Libelle, German Data Sheet No. 251, from Serial No. 2 and on, however, Serial No. 2 to 85 only, if the elevator actuator bracket has welded assembly guides instead of screwed guides.
Standard Libelle and
Standard Libelle 201 B, German Data Sheet No. 251, all Serial Numbers,
Club Libelle 205, German Data Sheet Nr. 304, up to Serial Number 107,
Hornet, up to Serial Number 3

Subject: Reinforcement of the elevator assembly guides.

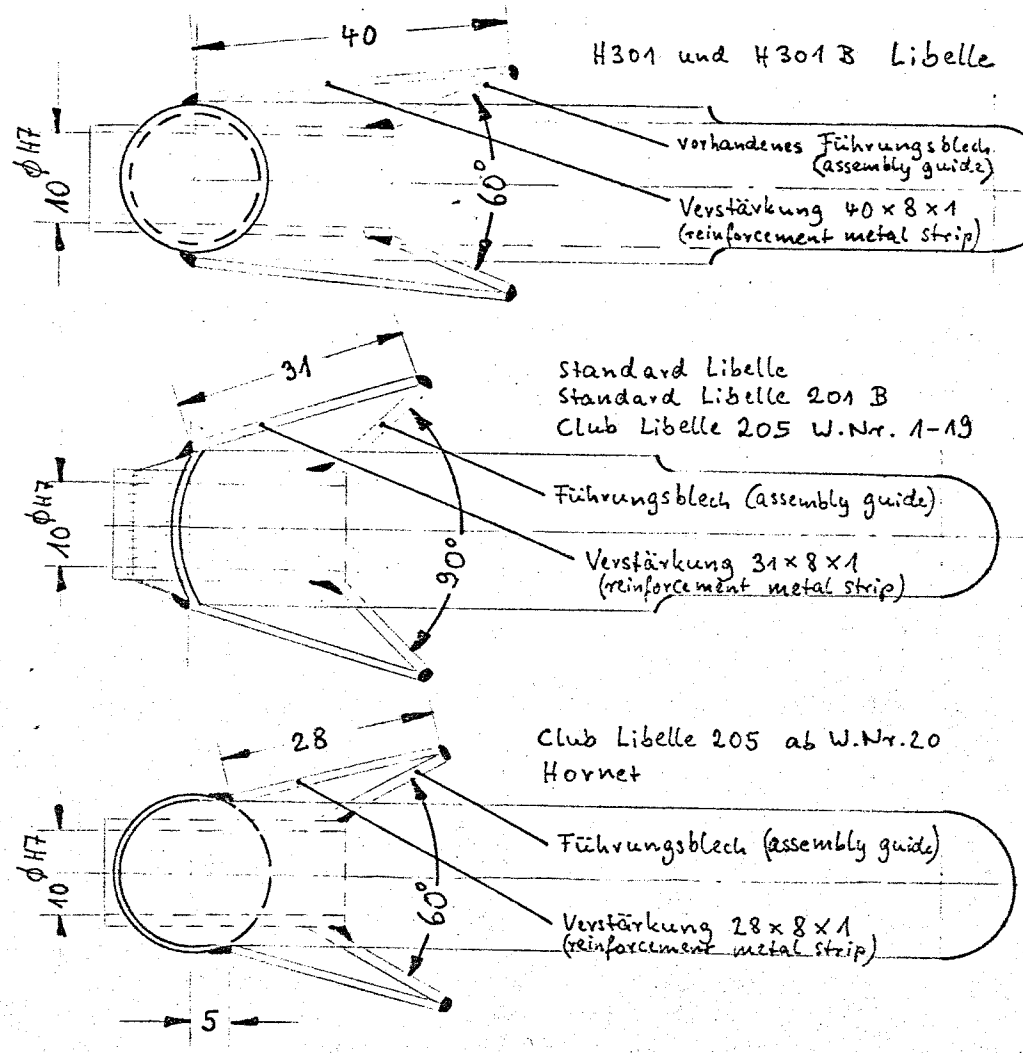
Reason: Careless assembly of the tailplane caused damaged elevator assembly guides, resulting in a possible improper assembly of the tailplane and loss of elevator control.

1. With a 5 x powered magnifier visually inspect the assembly guides for distortion, bending and/or for cracks in the welded seam.
2. If damage is found replace the bracket immediately with a bracket to be reinforced according to method 4.
3. If no damage is found replace the bracket with a bracket to be reinforced according to method 4 before the date quoted in "Urgency".
4. Weld in two sheet metal strips according to the following drawings to reinforce both guides. (see next page)
