<u>Sailplane model:</u>	H 301 Libelle und H 301 B Std.Libelle, Std.Lib. 201 B, Std.Lib. 203 Club Libelle 205 und Hornet Kestrel Glasflügel 604 BS 1	ATC No. 251 251 304 276 281
-------------------------	--	---

Subject : Glass fiber laminate covering the spar stub fittings

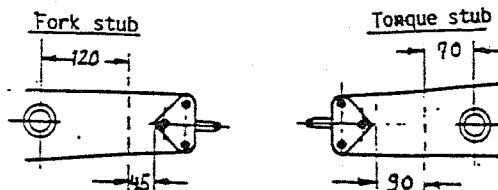
2. If corrosion was found on the fitting, proceed as follows:
First remove gelcoat from spar stub (if such was applied by the manufacturer) and remove laminate as shown in the sketch (such preparing the area to be scarfed later on) -

make sure that the spar flange rovings and the laminate connecting the upper and lower stubs halves are never been sanded. Furthermore remove any laminate adhering to the fitting.

Finally the spar stub glass layers must be re-wrapped (note displacement of 15 mm) as shown in the sketch on page 1 (using Scheufler Epoxy resin No. 285, mixed with hardener No. 285, laminate to be covered by Nylon cloth).

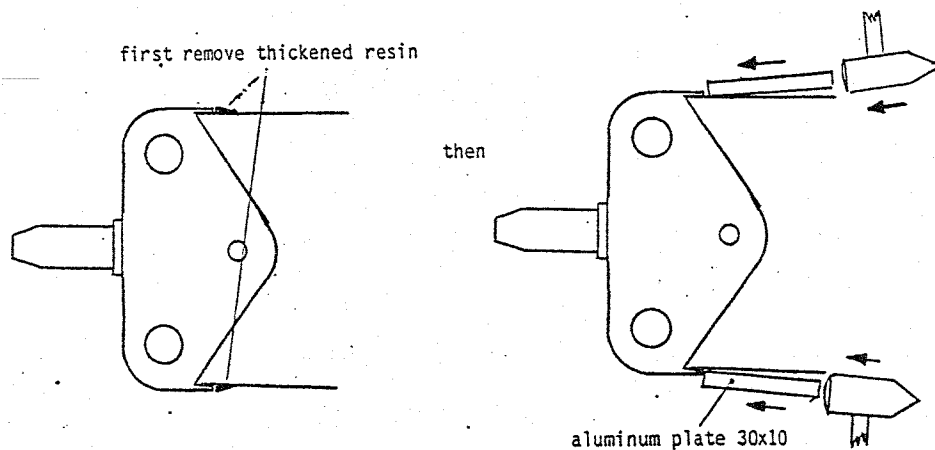
If there is suspicion that there is corrosion on the inner side of the fitting, it has to be removed as follows:

Drive out hollow rivets imbedded in the spar flanges - but make sure that a counter weight is held against the driving force, Thereafter, with rivets removed, carefully loosen and extract the fitting with the aid of an aluminum plate - see sketch.

Next sandblast the fitting (Using only approved material) and apply a fresh corrosion protection. Then carefully smooth the spar stub (using a 400 grid sand paper), apply a thin coat of resin, push fitting fully home and install hollow rivets. The step between fitting and stub and between connecting glass layers should be filled up using thickened resin.
