<u>Sailplane model:</u>	H 301 Libelle und H 301 B Std.Libelle, Std.Lib. 201 B, Std.Lib. 203 Club Libelle 205 und Hornet Kestrel Glasflügel 604 BS 1	ATC No. 251 251 304 276 281
-------------------------	--	---

Subject : Glass fiber laminate covering the spar stub fittings

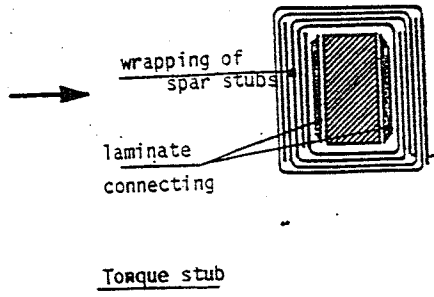
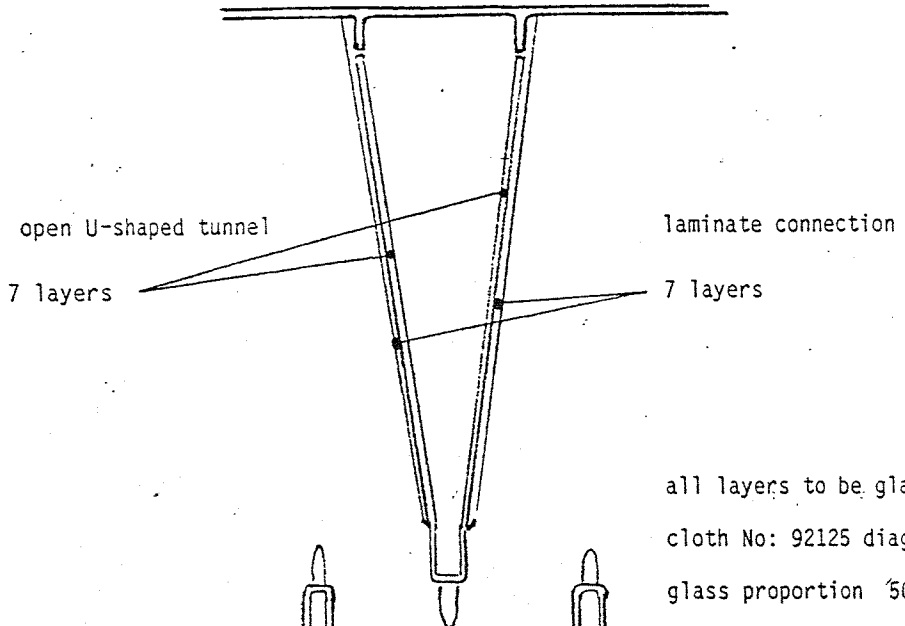
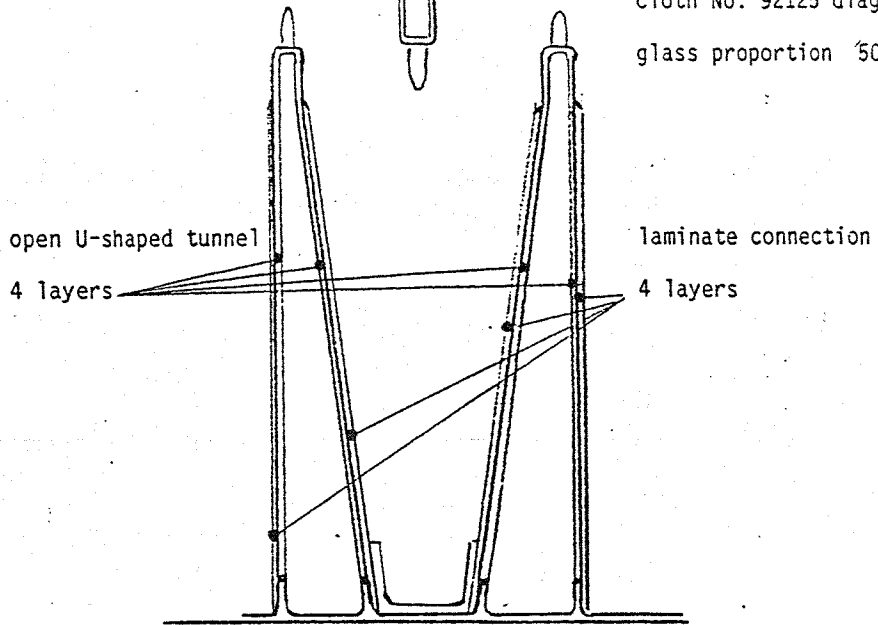
Torque stub

Model	Wrapping (diagonally) of spar stubs
201	Interglas 92 125 *
205	
206	
301	
401

The renewal of the wrapped stub laminate may only be conducted by a certified repair station.
